FIRE TESTS OF ADVANCED ARAMID **BLENDS AND TREATMENTS**

George H. Kydd and Joan C. Marano-Goyco Air Vehicles and Crew System Technology Department NAVAL AIR DEVELOPMENT CENTER Warminster, Pennsylvania 18974

DECEMBER 1987

FINAL REPORT

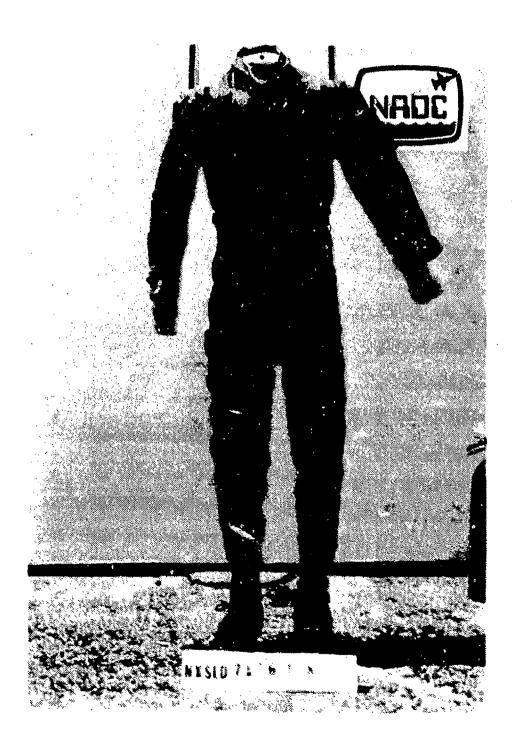
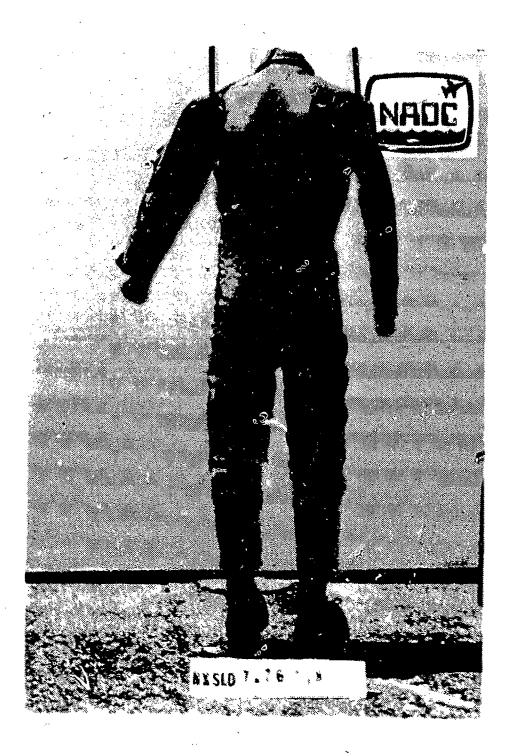
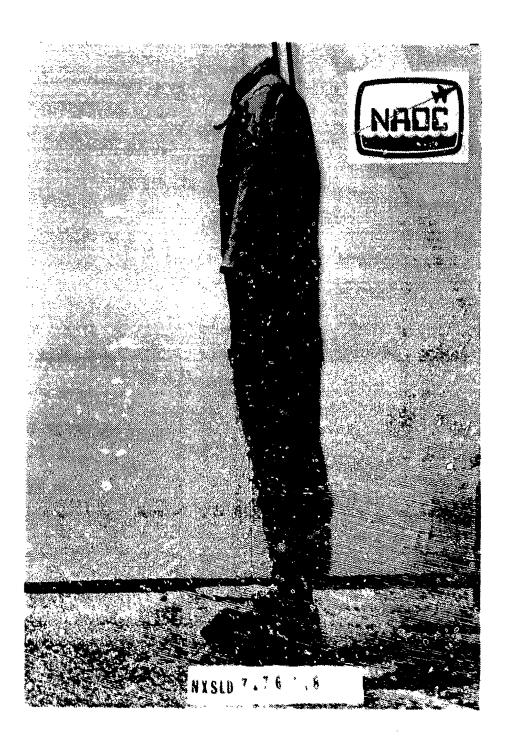
Figures 3, 4, and 5 show this flight suit before the exposure in front, back and side views. The still photographs taken after the exposure are whown in Figures 6, 7, and 8, front, back, and side views. These pictures show that there had been considerable shrinkage particularly in the legs.

Four to six inches of sock was showing above the boots, whereas before the test, the cuffs of the suic trousers were touching the boots. The ample amount of material that formed an irregular bubble in the back and wrinkles in the legs before burning had disappeared and the suit fit tightly after the test. The video tapes showed low, short purplish flames at the manikin's back during two of the tests (448 and 456), but they had disappeared by the time the manikin was over the edge of the pit. Also there was considerable smoking from the garment.

ligure 6. Front view of the Solution-dyed Nosex flight suit after a 3-second exposure.

Figure 7. Back view of the Solution-dyed Nomez flight suit after a 3-second exposure.

Figure 8. Side view of the Solution-dyed Nomex flight suft after a 3-second exposure.

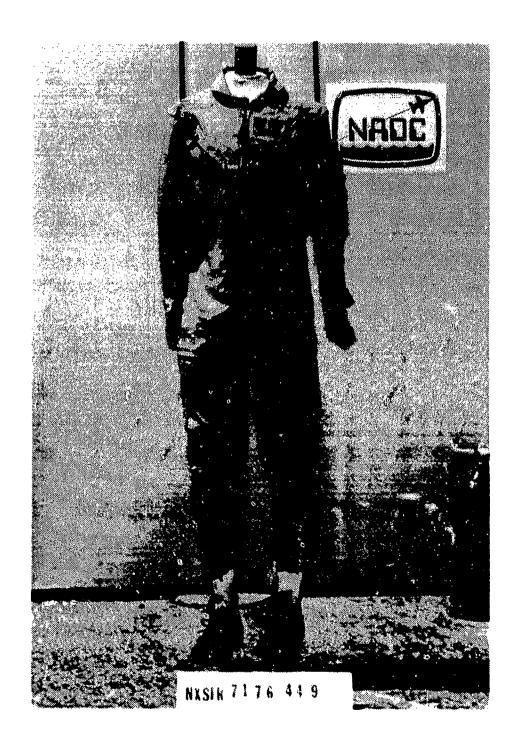
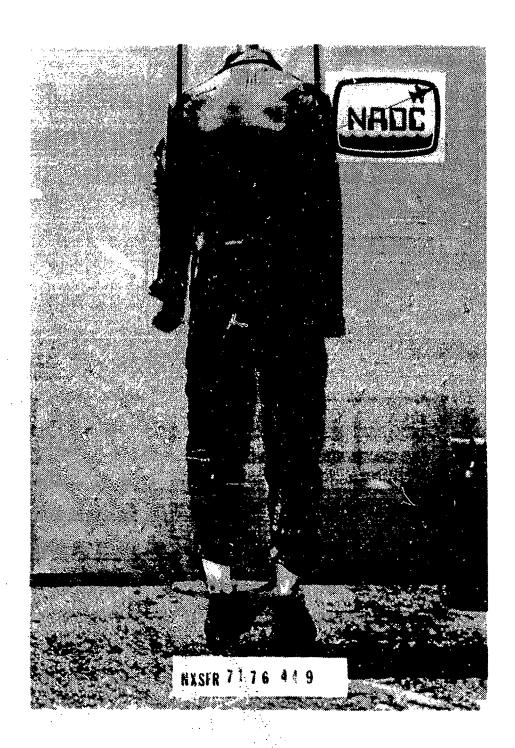
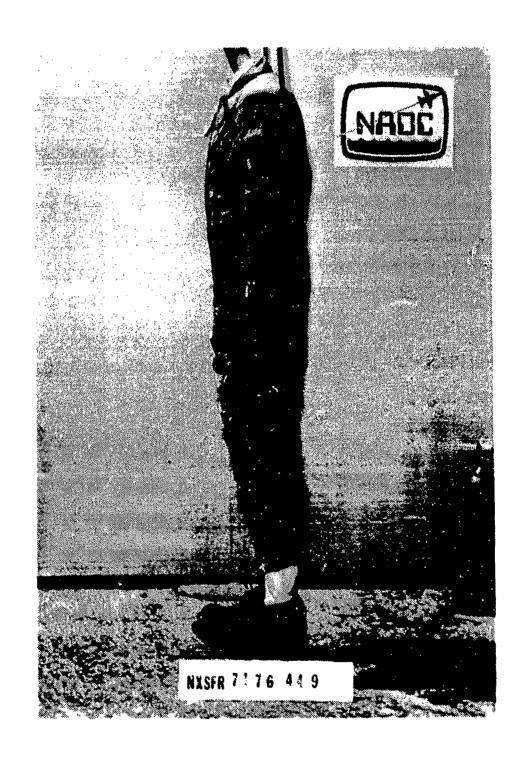
The photographs before the exposure are shown in Figures 9, 10, and 11, front, back and side views. The still photographs after the exposure are shown in Figures 12, 13 and 14. The results from the temperature sensors can be seen in Table II. They show that these suits faired better than the previous group, in that the average total body burned figure was well below 40% at 33.75%. No burning was observed at the exit from the flames. There was shrinkage as shown in the Solution-dyed suits and in one test there was asmall, 1 inch hole burned through.

Figure 12. Front view of the Super flame-resistant Nomex flight suit after a 3-second exposure.

Figure 13. Back view of the Super flame-resistant Nomex flight suit after a 3-second exposure.

Figure 14. Side view of the Super flame-resistant Nomex flight suit after a 3-second exposure.

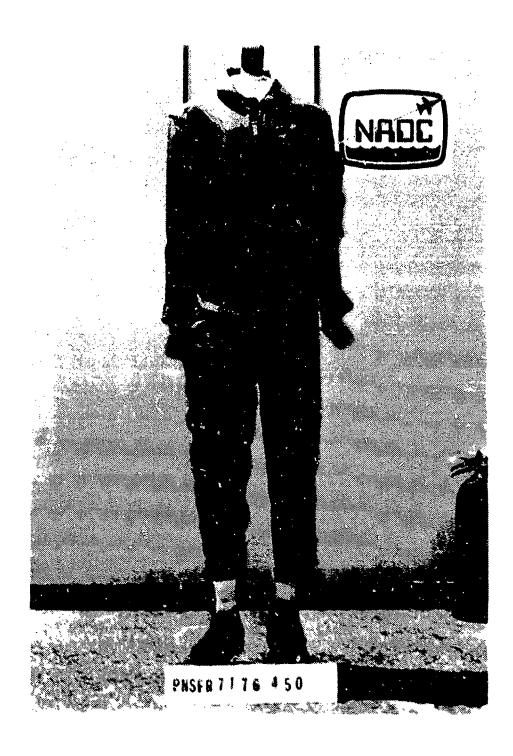
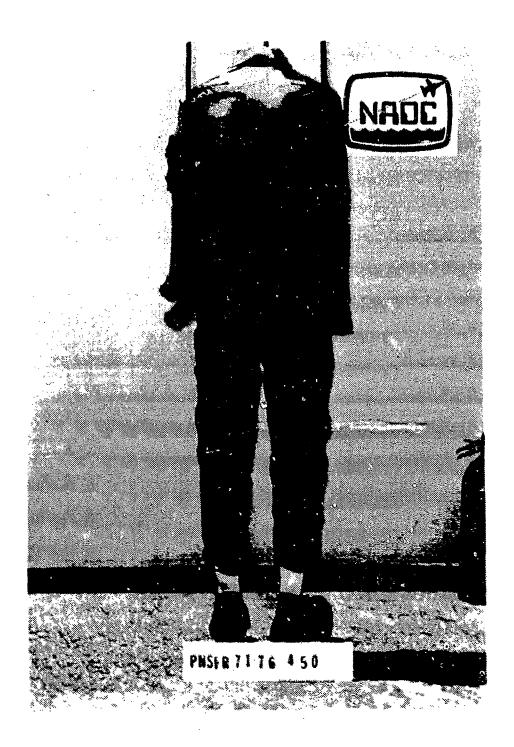
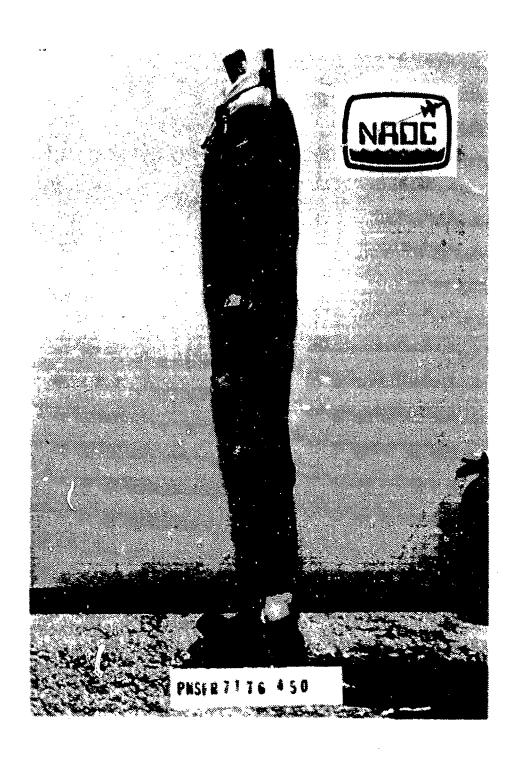
The PBI-Super flame retardant Nomex blend comprised the third garment to be tested and is shown in Figures 15, 16 and 17, front, back and side views. The photographs taken after the exposure are shown in Figures 18, 19 and 20. These photographs confirm shrinkage in the legs but not as much as in the Solution-dyed Nomex. There still are some wrinkles in the suit. These suits are identified as follows in Table II:

Figure 18. Front view of the PBI-Super flame-resistant Nomex flight suit after a 3-second exposure.

Figure 19. Back view of the PBI-Super Clase-resistant Nessex (light suff After a 3-second exposers.

Figure 20. Side view of the FBI-Super flame-resistant Nemex flight suit after a 1-second exposure.

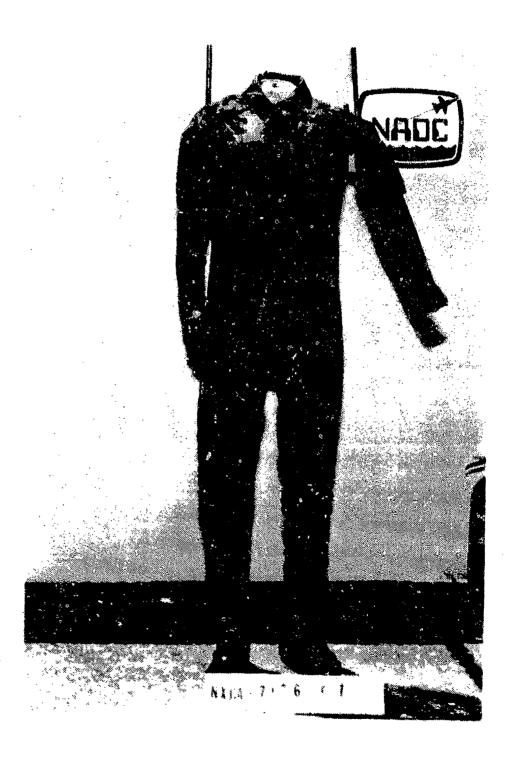
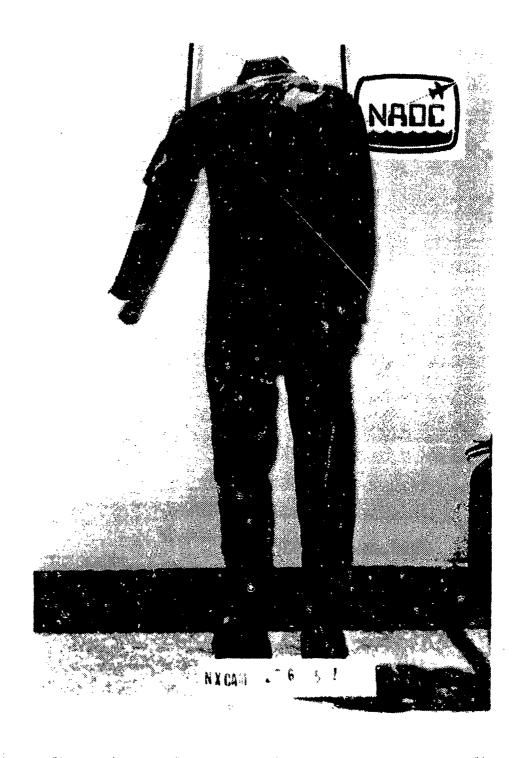
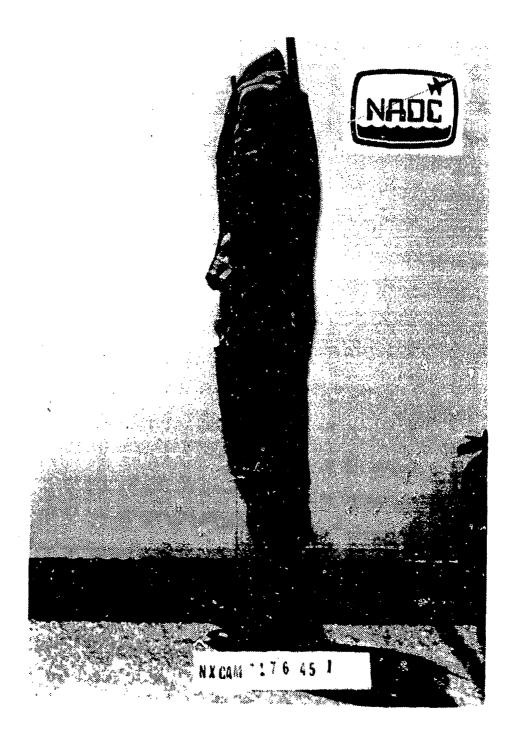
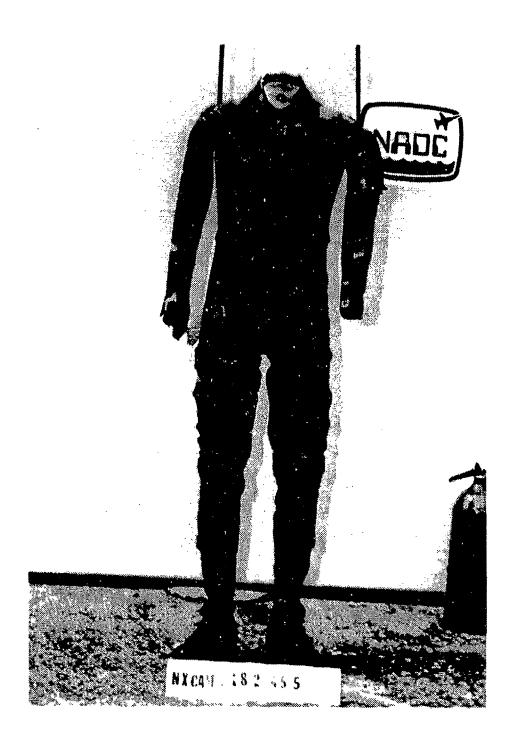
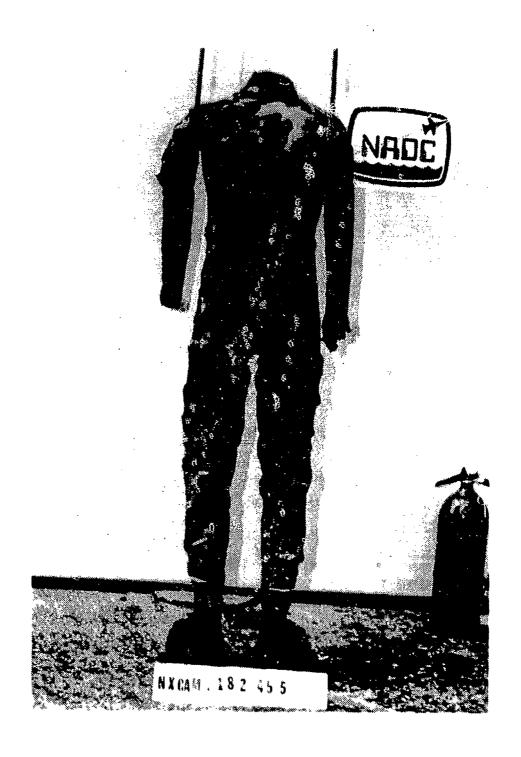
and is shown in Figures 21, 22 and 23, front, back and side views. The photographs after the exposure are shown in Figures 24, 25 and 26. These photographs show that the Nomex camouflage appeared to be little affected by the exposure in spite of the fact that the camouflage print tends to obscure gross shrinkage. No flaming was seen in any of the 3 second exposures of this specimen. There was smoke and some shrinkage. The temperature effects are shown in Table II. Of the four types tested: NXCAM averaged the smallest percentage burns in torso and legs, while for the arms the percentage was intermediate among all four types. Overall the average NXCAM total percentage body burned was lowest, 29,92%. The worst case result is shown in Figures 27 and 28. This was NXCAM 7182 455 that had 45.5% body burned. There is more uniform shrinkage and more discoloration of areas in Fig 28, back view, manikin's left, that shows some general heating effects, a brownish discoloration covering the manikin's left torso, left buttocks and left leg.

Figure 24. Front view of the Super flame-resistant Nomex Camouflage flight suir after a 3-second exposure.

Figure 25. Back view of the Super flame-resistant Nomex Camouflage Hight suit after a 3-second exposure.

Figure 26. Side view of the Super flame-resistant Nomex Camouflage flight suit after a 3-second exposure.

Figure 27. Front view of a second Super Clame-resistant NOMEX Camoullage flight suit after a 3-second exposure.

Figure 28. Back view of a second Super flame-resistant Nomex Camouflage flight suit after a 3-second exposure.

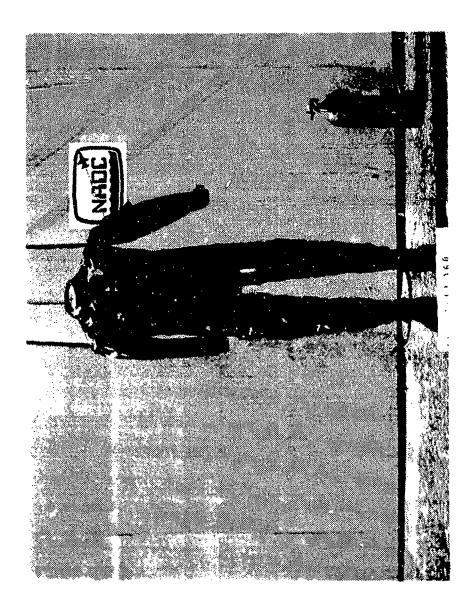
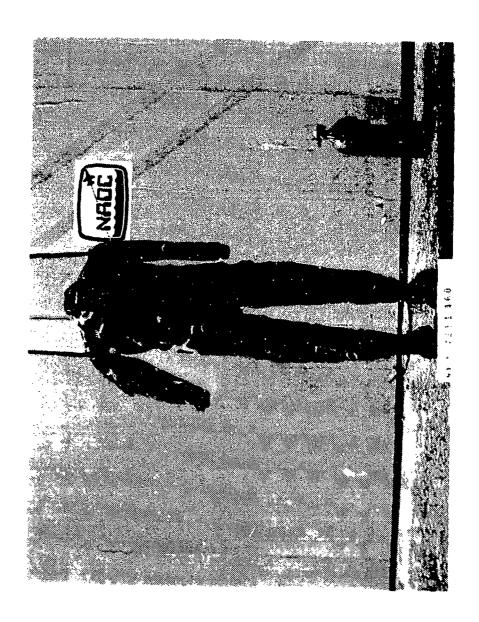
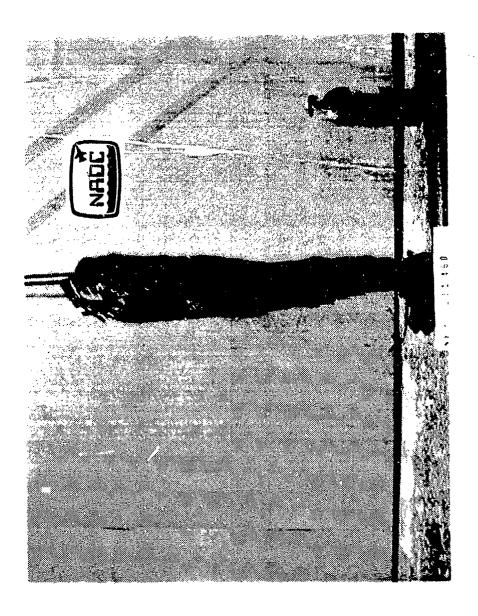
At the outset of this 3 second series, it was decided to test an additional suit at four seconds of the type which resulted in the least percent body burned at three second tests. The winner was the Nomex Camouflage and the results of this test are shown in Figures 29, 30 and 31 for front, back and side views. There was some burning as described above in the

Solution-dyed Nomex but no after-flaming. At 9.03Cal/cm² this was the greatest burn as expected.

Figure 29. Front view of the Super Hame-resistant Nomez Camoullage Hight suit after a 4-second exposure.

Figure 30. Back view of the Super flame-resistant Nomex Camouflage flight suit after a 4-second exposure.

Figure 11. Side view of the Super Classe-registrant Somex Camonillage Hight and after a A second exposure
